BEAUFORT SEA COASTAL RESTORATION PROJECT

2020
ANNUAL
RESEARCH
UPDATE

Project Summary

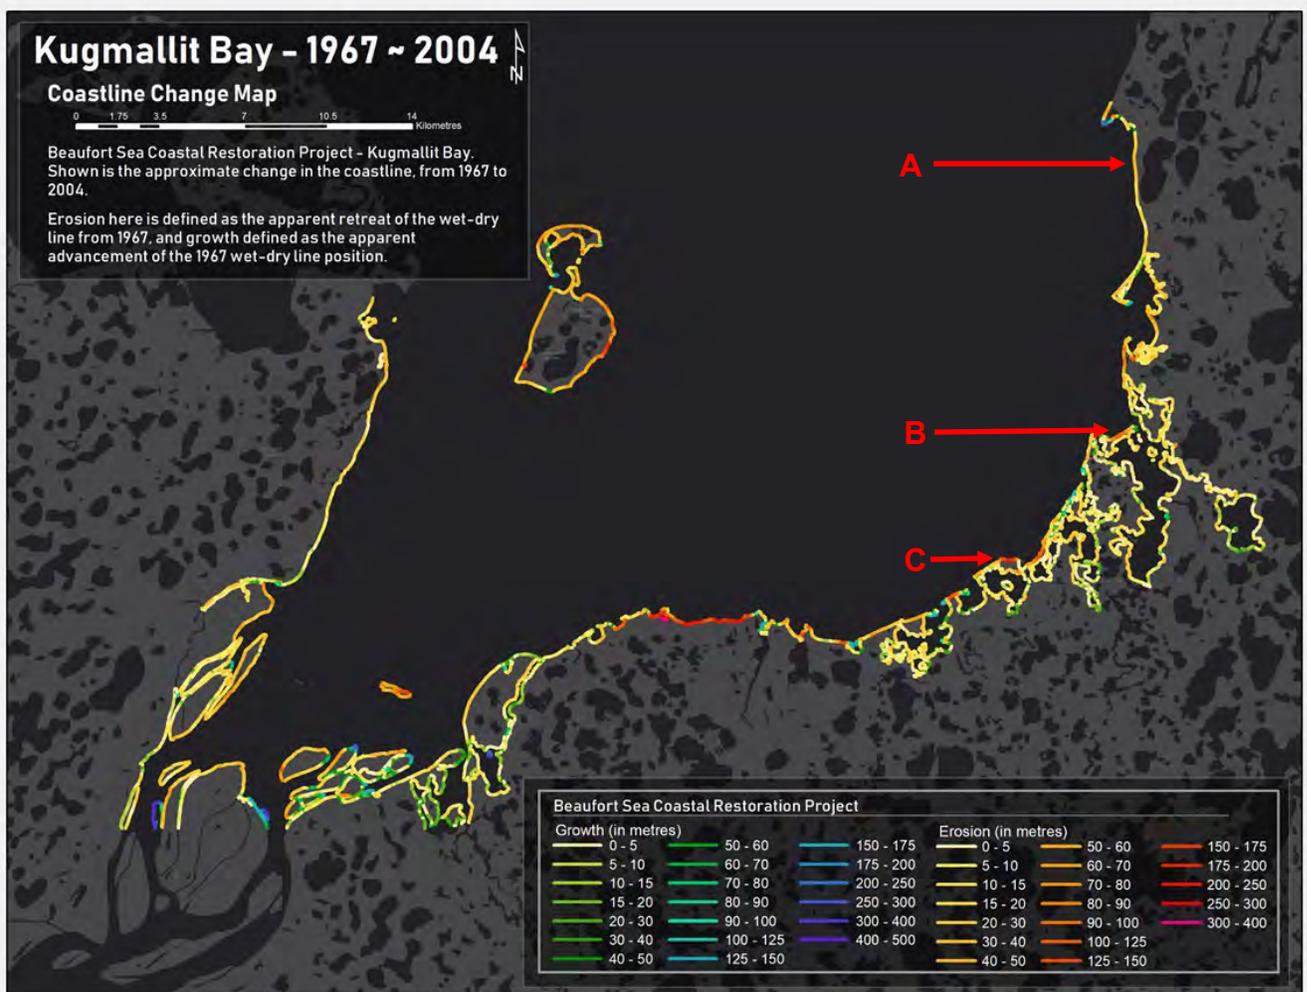
Below, is a map of Kugmallit Bay. The colours represent the rate of coastal erosion (or aggradation) in metres. This was created using historical aerial photographs of Kugmallit Bay, which were obtained in 1967 and 2004. The letters indicate the location of the three main study sites. They are as follows:

- A** Galiptat Area (North Pingo Point)
- B** Tuktoyaktuk Island
- C** Imnaqpaaluk (Peninsula Point)

Figure 1: A map illustrating how much (in metres) the coastline retreated between 1967 and 2004.

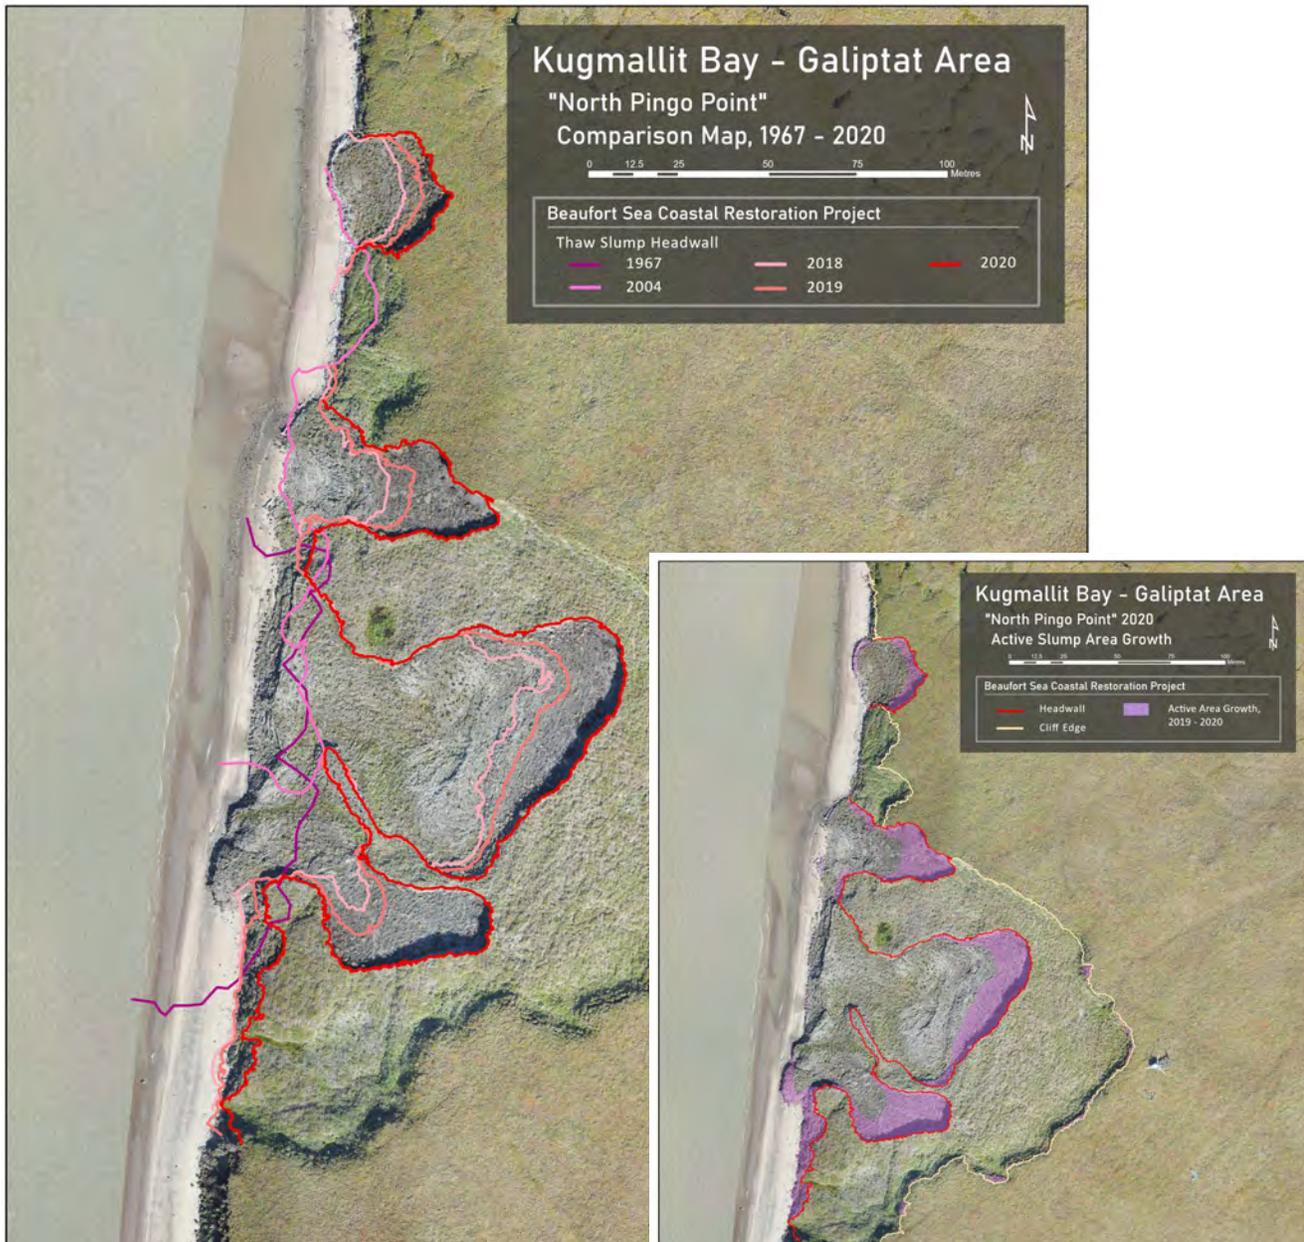
Historical aerial photographs, in combination with UAV imagery, was used to map the progression of thaw slumping in the Galiptat Area between 1967, 2004, 2018, 2019, and 2020. Additional drone surveys are planned for 2021.

Figure 2: An overhead view of a large thaw slump in the Galiptat Area. The lines show the location of the headwall in 1967, 2004, 2018, 2019, and 2020. The shaded portion represents the amount the headwall retreated between 2019 and 2020.

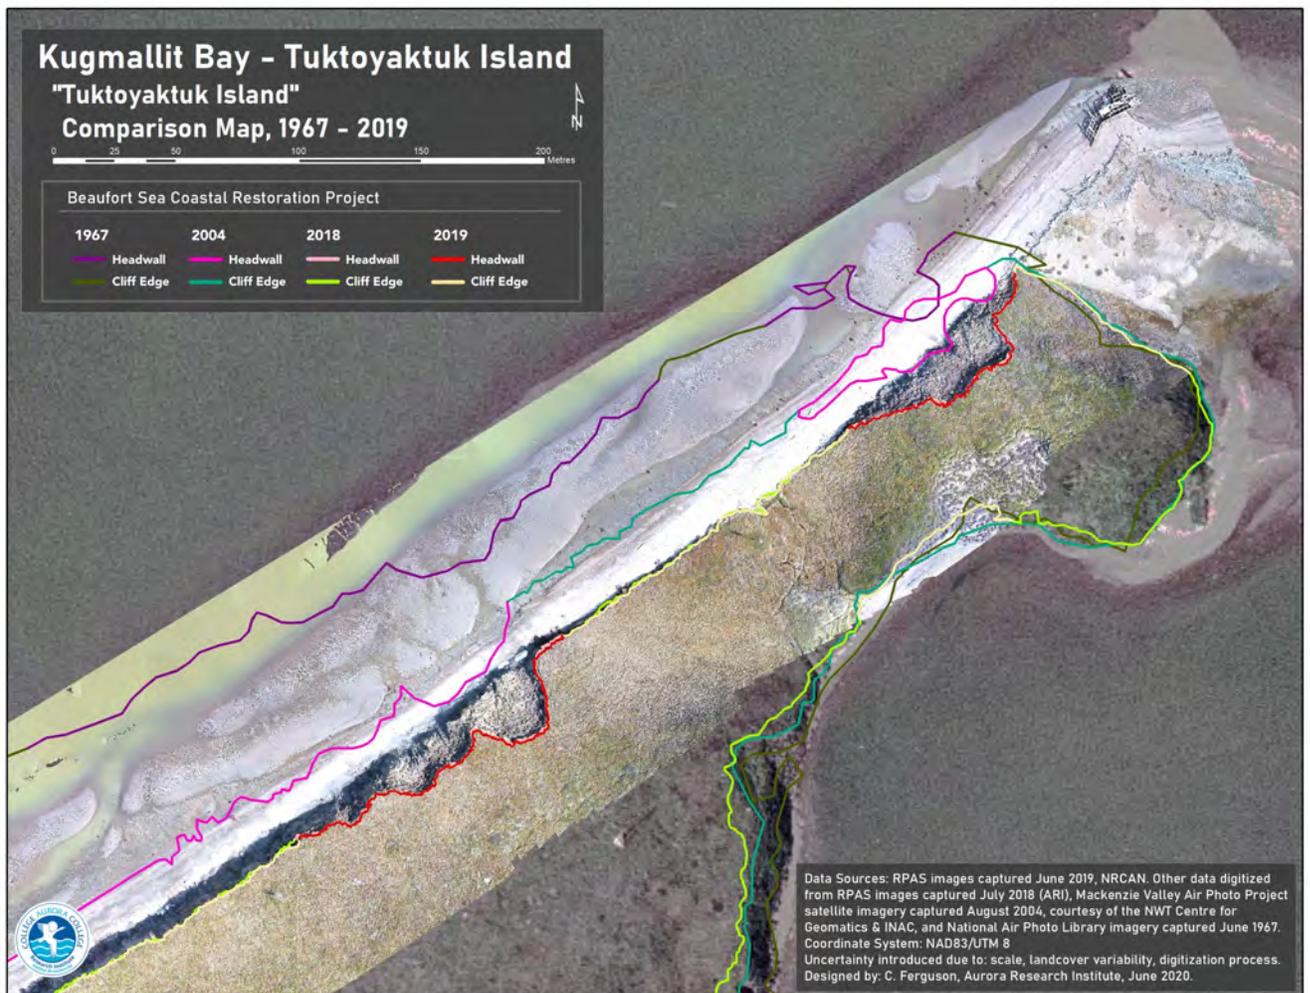
Historical aerial photographs, in combination with UAV imagery, were used to map the progression of thaw slumping on Tuktoyaktuk Island between 1967, 2004, 2018, and 2019. New Canadian Aviation Regulations restricted the Aurora Research Institute from flying this site in 2020. Since the technicians at ARI now have their Advanced RPAS Licenses, an additional drone survey is planned for 2021.

Figure 3: An overhead view of a large thaw slump on Tuktoyaktuk Island. The lines show the location of the headwall in 1967, 2004, 2018, and 2019.

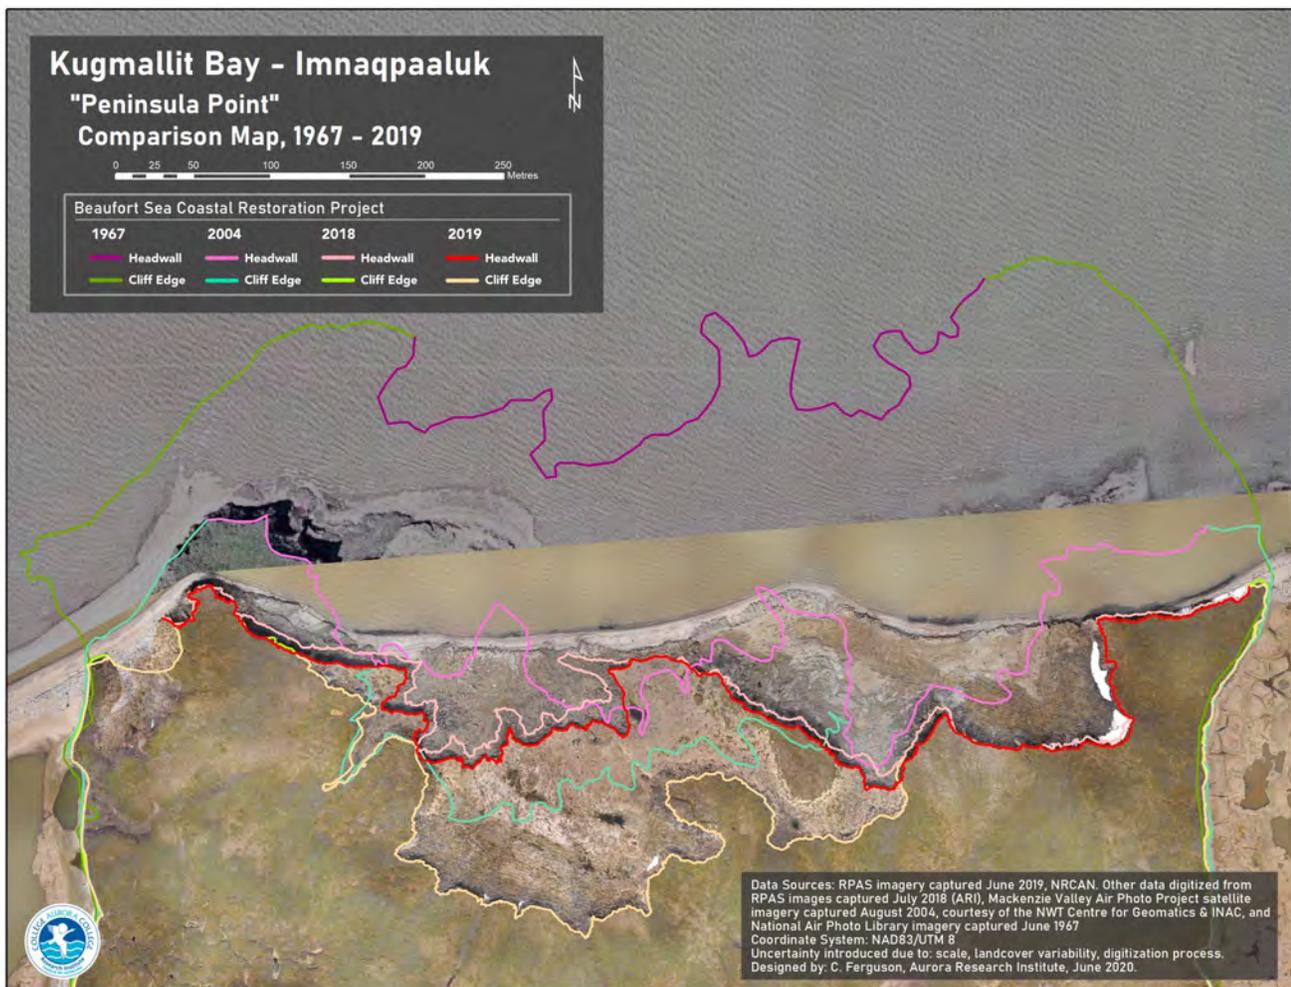
Historical aerial photographs, in combination with UAV imagery, was used to map the progression of thaw slumping at Imnaqpaaluk (Peninsula Point) between 1967, 2004, 2018, and 2019. New Canadian Aviation Regulations restricted the Aurora Research Institute from flying this site in 2020. Since the technicians at ARI now have their Advanced RPAS Licenses, an additional drone survey is planned for 2021.

Figure 4: An overhead view of the large thaw slump at Imnaqpaaluk (Peninsula Point). The lines show the location of the headwall in 1967, 2004, 2018, and 2019.

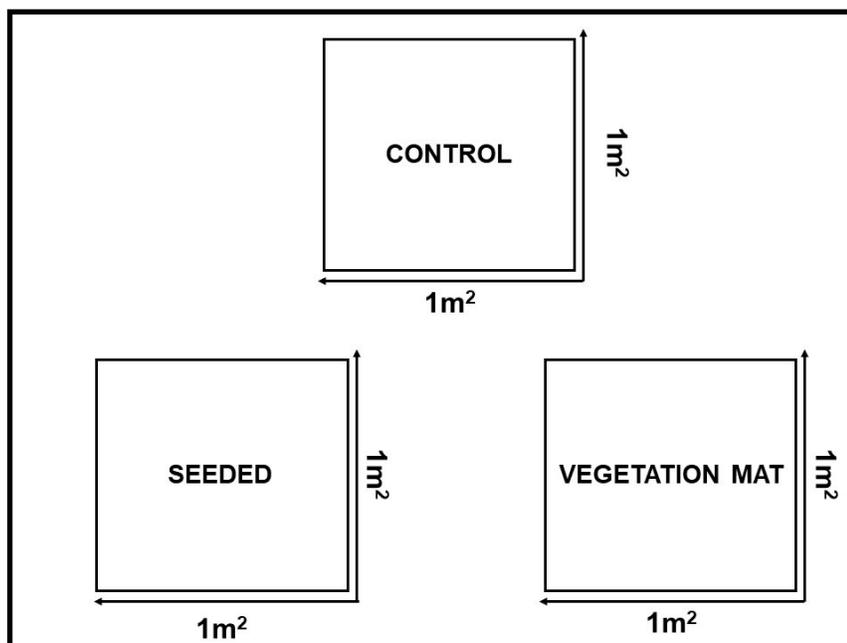
The field team established 3 experimental manipulations within each thaw slump (see Figure 5). Each manipulation consisted of three 1m² plots.

Figure 5: Diagram of one experimental manipulation. Each manipulation has 3 quadrats (one control, one seeded, and one with a vegetation mat). Three Test Plots were established at each study site (Imnaqpaaluk or Peninsula Point, Galiptat Area or North Pingo Point, and Tuktoyaktuk Island).

The first test plot was left

bare (control). The second plot was seeded using a mixture of seeds collected in the previous year (see Figure 6 on Page 10 for a list of the species that were used and a map of the seed collection sites). By comparing this quadrat to the bare (or control) quadrat, we should be able to test whether manual seeding is more effective than wind dispersal, which occurs naturally.

The third plot was covered using a vegetation mat. The vegetation on each mat was characterized by

Ground Temperature sensors were installed at 0.5m, 1m, and 1.5m beneath each plot. This will allow us to examine how seeding and vegetation mats influence near-surface ground temperature.

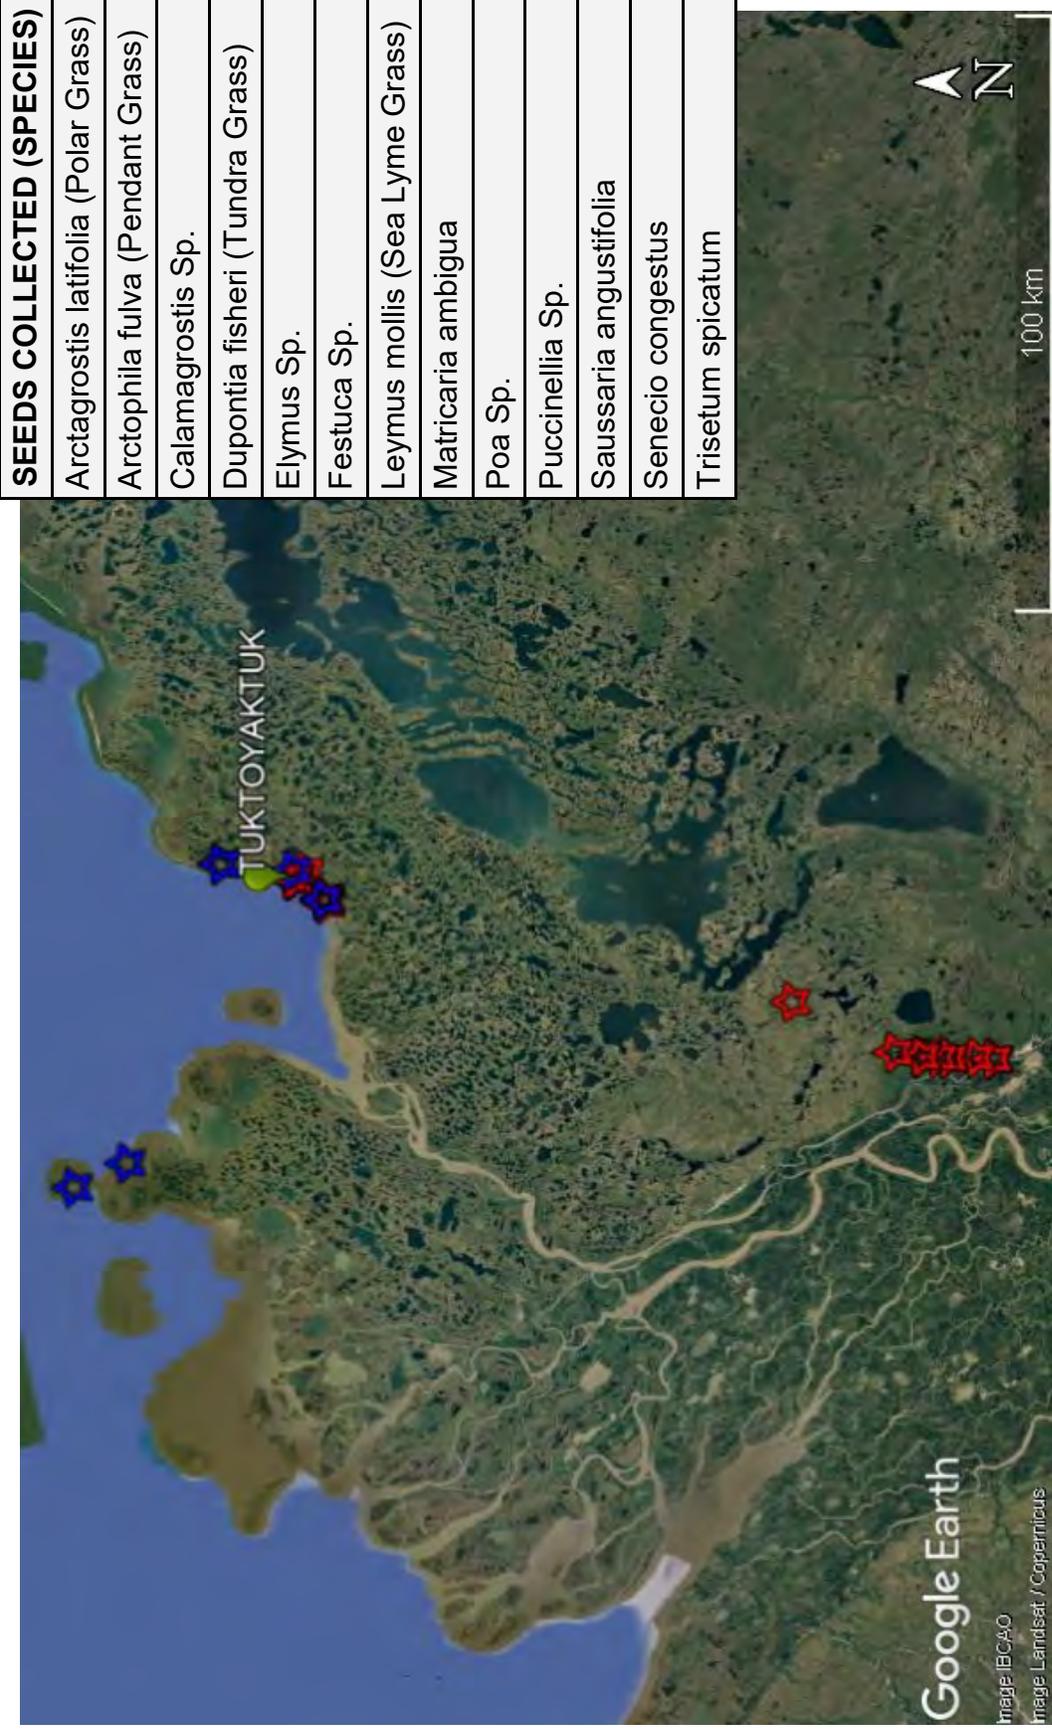
Figure 6: Seed collection sites are indicated in red. The seeds collected are listed in the table on the top right corner. Water sampling sites are indicated in blue.
